## THE CHALLENGE: Cooling tower revamping in an oil refinery

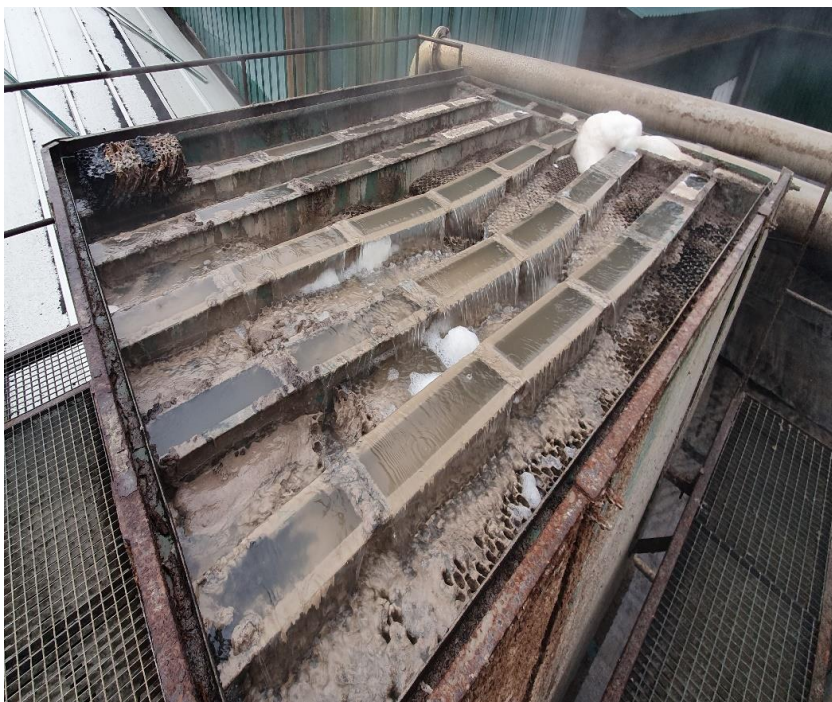
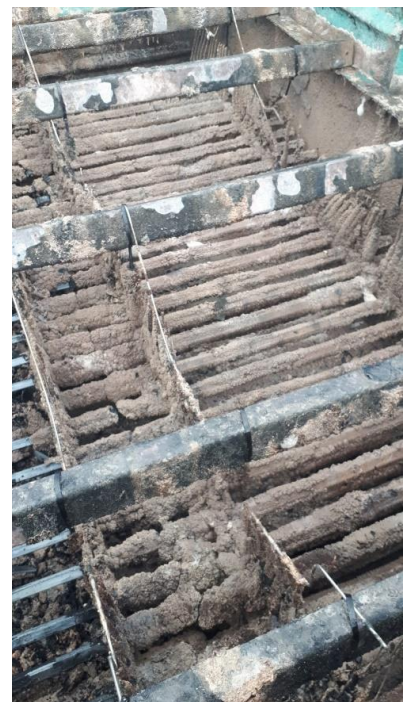
It is an 18-year-old Torraval forced draft cooling tower that had not undergone any repair, interior cleaning or fill pack change along the time. The water carried fatty acids from the refining process and although the tower was provided with a special drip fill pack for water with high solids content, the low maintenance caused the break of the mesh that hold the fill due to the accumulated weight, falling to the cooling tower raft part of it.

The cooling tower was seriously damaged in its structure by the fall of the fill and the weight supported for years. The client require us fix or replace the cooling equipment in the shortest time possible.
