Cooling in **chemical industry** faces challenges such as process water acidity, which causes materials degradation. Corrosion is a constant to combat. It causes thinning cooling towers metal parts and forms deposits in pipes, resulting in inefficient operation of the equipment, which leads to shutdowns for corrective maintenance.

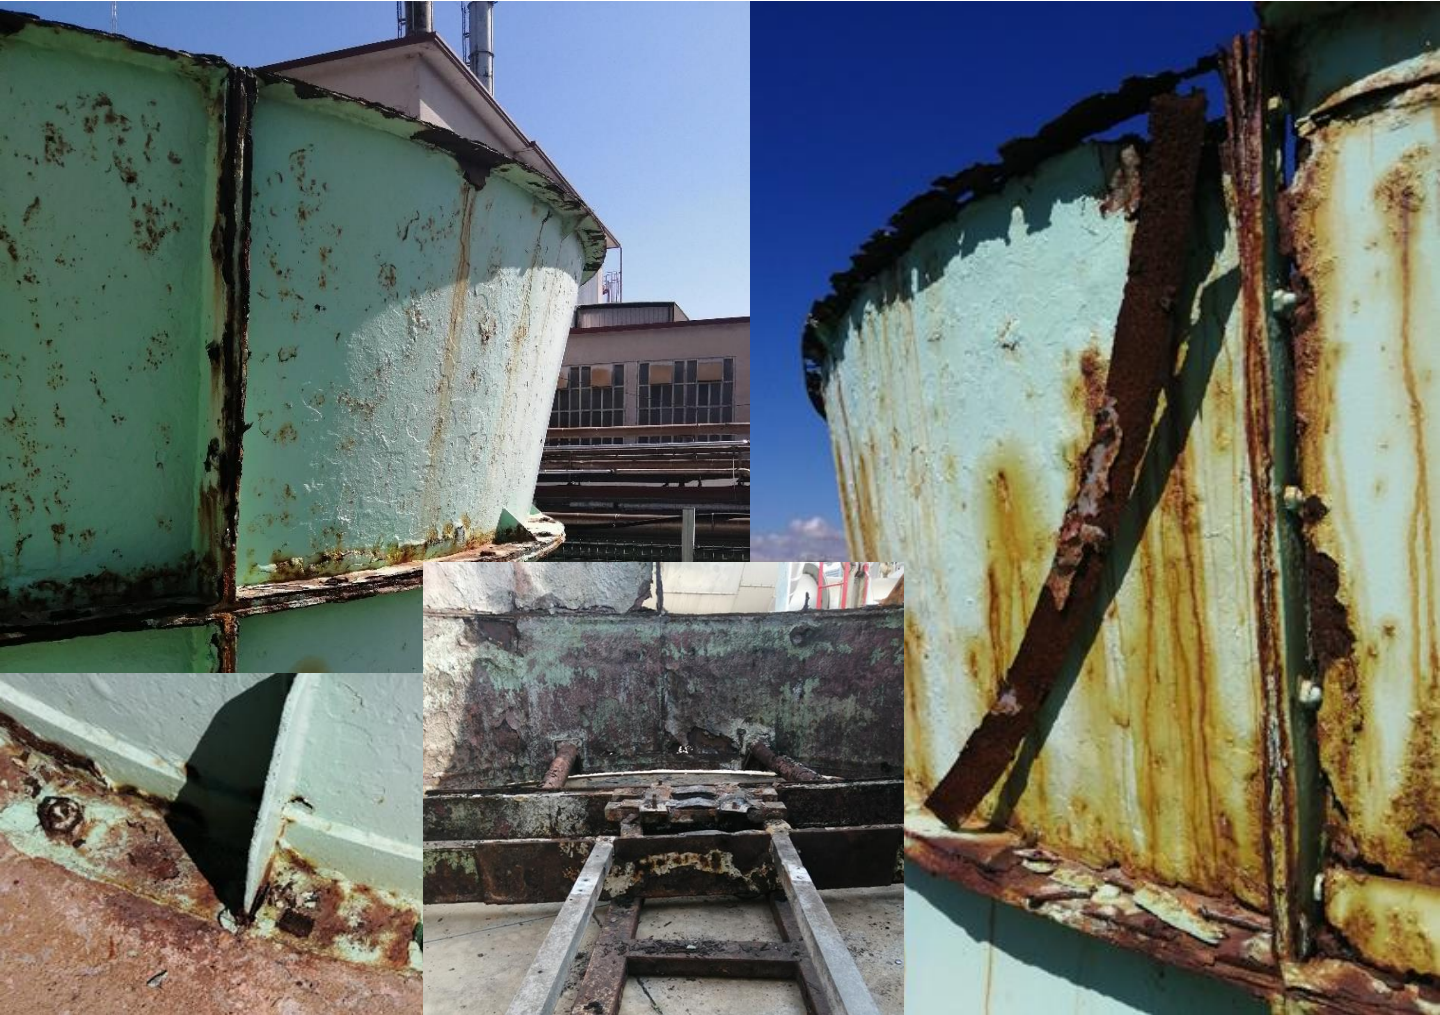
- Steel diffusers replacement which were in very bad condition due to rust.
- Fan base substitution due to risk of detachment.

- To definitively solve the problem of metallic corrosion in the cooling tower diffuser, it was designed one in polyester reinforced with [fibreglass GRP](#).
- In the case of the fan base, a new stainless steel one was selected, which is also fixed to the concrete base, giving the system greater robustness without transmitting stresses to the diffuser.
